Application Focus

Lining of Process Vessels

Solution for Internal Protection of Process Vessels

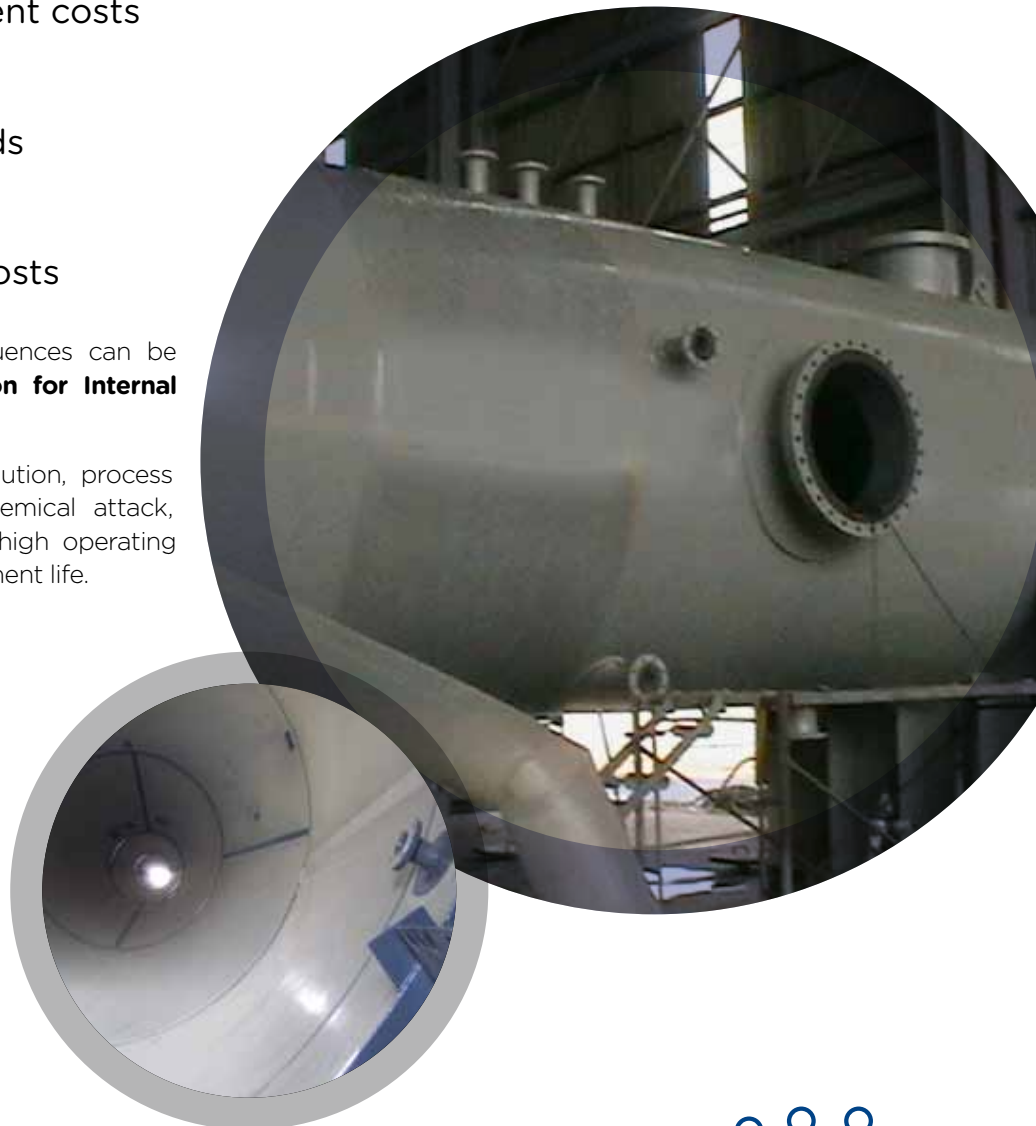
Application Case Study

“The internal vinyl ester glass flake coating had failed in a process vessel at a refinery, leading to substrate pitting and corrosion. This failure was due to the presence of sour water and operating temperatures of up to 100°C.”

Belzona provided a cost effective alternative solution, which could **resist immersion temperatures of up to 248°F (120°C), tolerate a wide range of chemicals and demonstrate very high erosion resistance.**

An inspection nine years later found the system to still be in good condition.
